The Mortenson Ranch Story: Balancing Environment and Economics

W. Carter Johnson and Malia A. Volke

Department of Natural Resource Management
South Dakota State University
Brookings, South Dakota

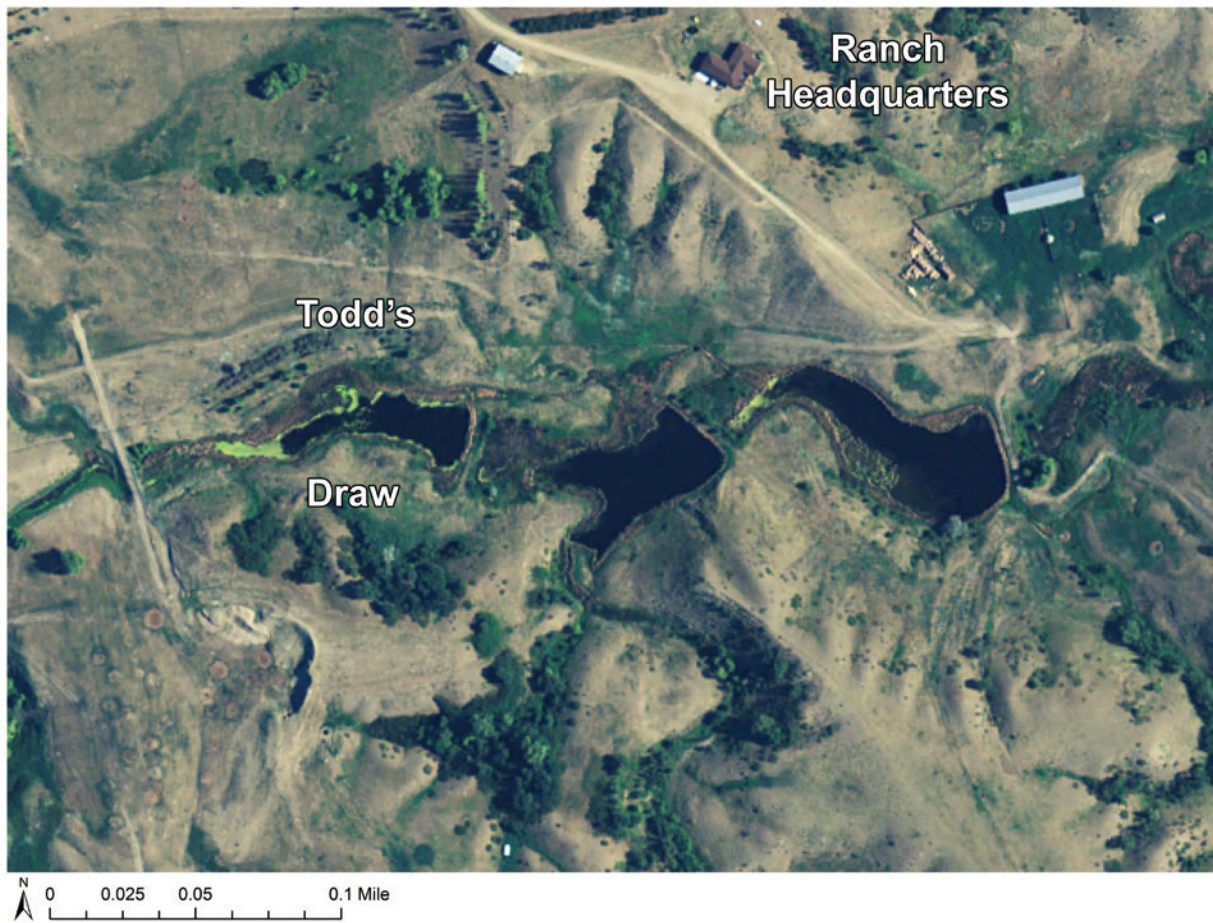
Figure 10. Location of "speed bump" dams in Todd's Draw on the Mortenson Ranch Home Place. Image Source: U.S. Department of Agriculture, National Agriculture Imagery Program (2012).

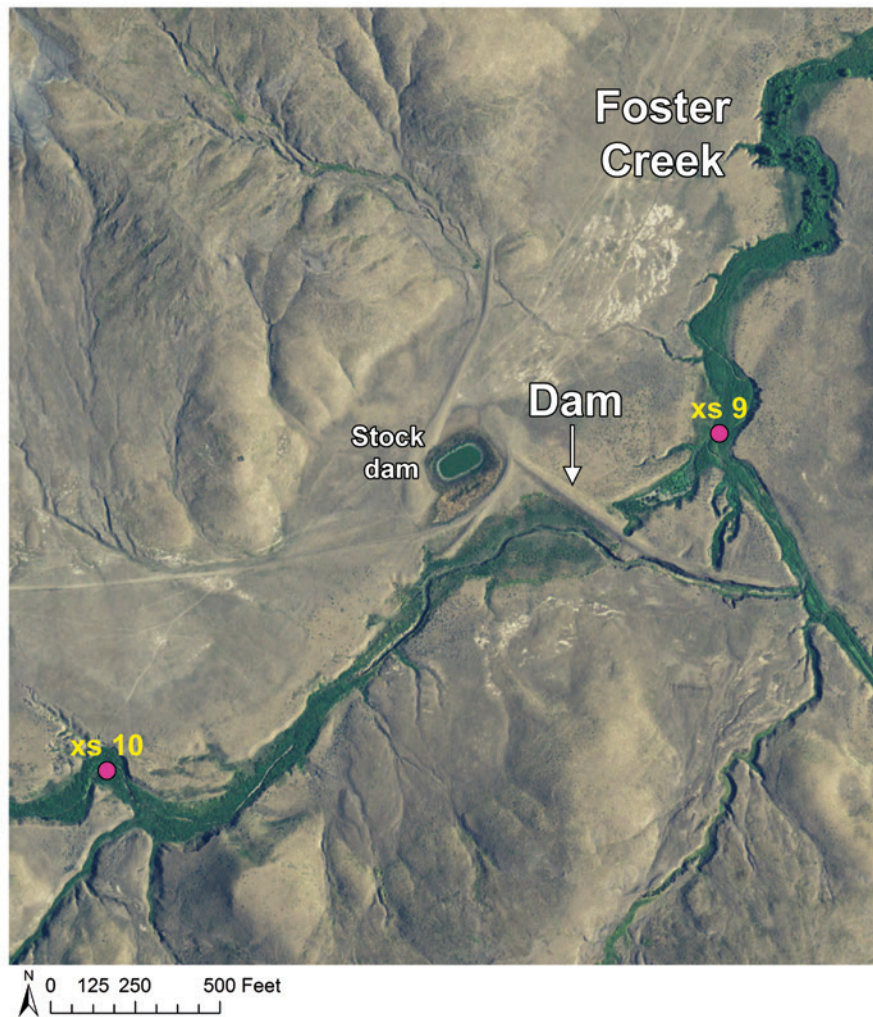
Figure 12. Close-up aerial view of two cross section locations, one silt-collecting dam, and a stock dam along Foster Creek on the Mortenson Ranch. Image source: U.S. Department of Agriculture, National Agriculture Imagery Program (2012).

The first dams were built on Foster Creek in the mid-1980s with the goal of filling gullies and rebuilding the floodplain and adjacent aquifers (Figure 12). Building dams for the purpose of capturing sediment and to leak slowly to sub-irrigate riparian vegetation was not approved of by the Soil Conservation Service (SCS) at first. The main purpose of SCS funded dams then was to hold water tightly to water stock and provide wildlife habitat and recreation opportunities (fishing and hunting). Hence, the first two dams were paid for by the Mortensons. In 1993, the SCS reconsidered and developed a cost-share plan to help build more dams on Foster Creek.

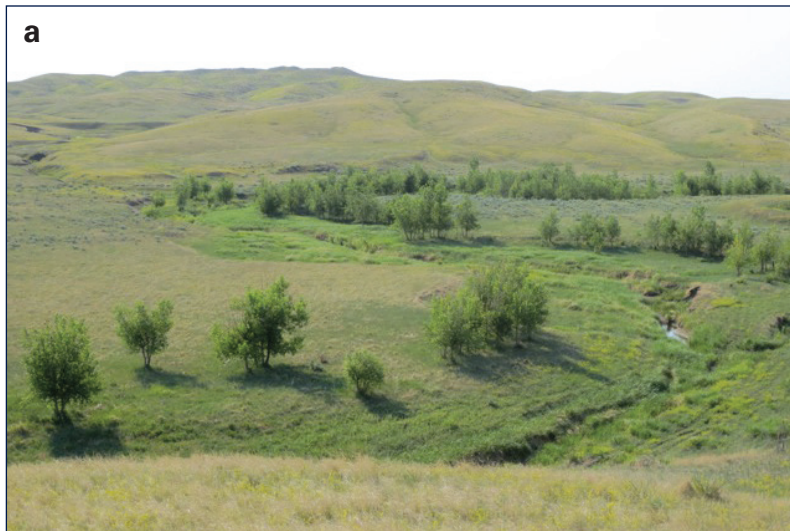
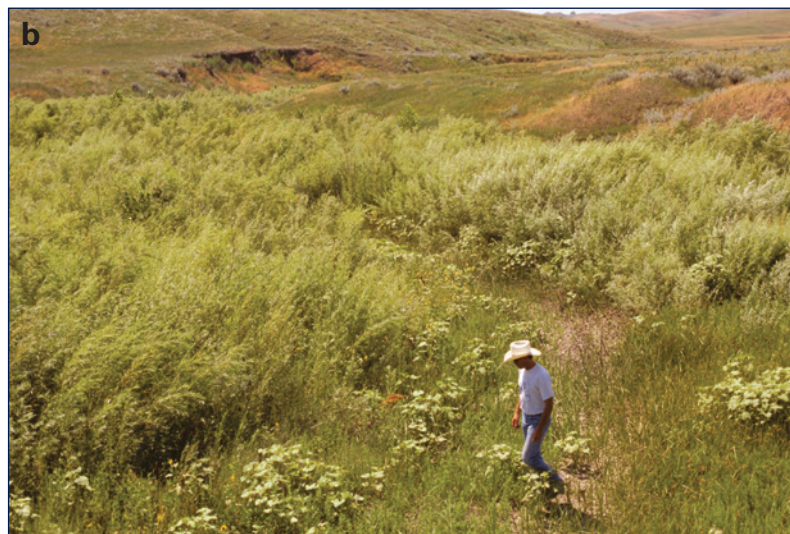
Figure 20a,b. Vegetation established following dam construction and changes in grazing on the Foster Creek floodplain. Woody vegetation in (a) is dominated by cottonwood and willow trees; (b) is dominated by willows (Todd Mortenson checking progress).

The goal of restoring a tree-lined channel to Foster Creek also has not been reached. However, there are scattered patches of cottonwoods and willows along the creek (Figure 20a,b), and seedlings of these trees have appeared along most reaches at one time or another. This indicates that the physical environment for germination and establishment has improved with the re-engineering of the channel. The absence of a more continuous and thicker stand of trees along the creek, however, appears to have three causes: competition with prairie cordgrass, physical damage of young trees by cattle during the non-growing season, and felling by beaver. Trees may have been a “victim” of the success of prairie cordgrass, a highly desirable, native wetland plant that spreads by rhizomes, holds soil tightly, outcompetes most other plants, and forms a thick mat or mattress of “hay” over the winter (Figure 21). These cordgrass mattresses insulate wintering herds of cattle while bedded down on frozen ground, significantly improving their energy budget and overall condition. In places where cordgrass dominates, trees do not have much of a chance to grow large enough to escape physical damage from cattle and to compete with cordgrass for nutrients and light. On the other hand, cordgrass also captures sediment during floods by adding surface roughness and helping the ranch managers to reach their other goal to build-up the floodplain, thus improving the long-term chances for trees to establish and survive and keeping more sediment out of Foster Bay and Oahe Reservoir.
